Conservation purpose material testing of corrosion products on outdoor bronze statues

Abstract. A detailed material testing was carried out before the conservation project of the János Arany statues of Garden of Hungarian National Museum. The scope of the testing to analyse the corrosion products on the surface and help to develop the best cleaning and protection practice. Samples were taken from more areas and the samples were analysed by SEM-EDS, XRD, FT-IR methods. This article introduces the results of the testing and the relevant effect to the conservation process.

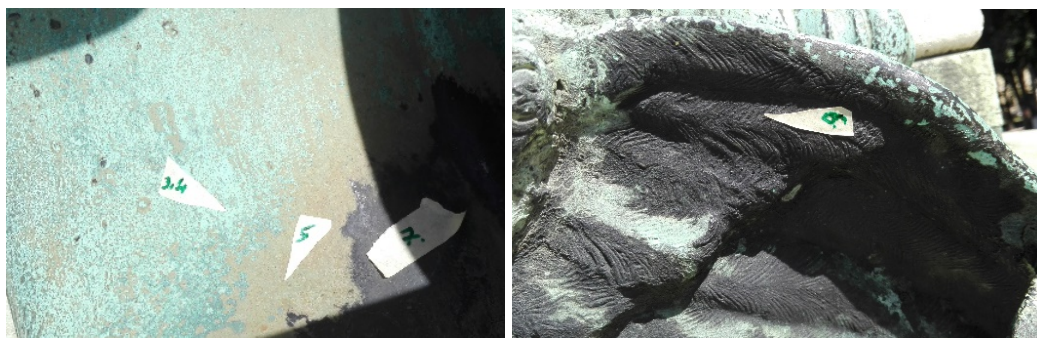
Figure 2. The different type of corrosion products on the surfaces of status. Right image shows a black and porous green layer, left image shows the continuous green and yellow-brown layer with a black covered area.

Field portable X-ray fluorescence (pXRF) analysis was performed on the statues in several regions. The aim of this examination was to determine the elements and assumed chemical composition. Basically, four different corrosion products were identified on the surface: i, surface areas covered by black layer; ii, yellow-brown layer; iii, porous green layer on the surface; iv, continuous ductile green layer. The documentation wrote a bronze base material. Measurements in different areas have been confirmed the documentation's copper and tin content. Silicon, aluminium and iron content also was detected in these areas. However, silicon and aluminium content were significantly higher in the black layer. Phosphorus was detected in the yellow-brown areas, which could be dangerous in terms of cleaning. Higher sulphur content was detected at the green layers, which originated to the patina first. Oxford XMET 8000 type pXRF analyser was used for the measurements. Powder samples were taken from the mentioned areas from more positions and statues. First energy dispersive X-ray spectroscopy (SEM_EDS) were made with a Hitachi S4300 CFE to study the structure and the chemical composition of the different materials. XRD measurement were made with a Bruker D8 Advance to identify the different compounds. Only a small amount of samples could be collected, so the identification was hard. FTIR analysis was performed to find possible remains of a prior treatment with organic or polymeric materials. Samples were taken from the continuous green sample; which brittleness was tested by microhardness tests.

The results suggest that it was necessary to remove the black and the yellow-brown layer from the surface of the statue. The green layers could be left over the surface and could be used a patinating process to equalize the outlook of the surface. The black and yellow-brown layers are brittle layers and easily detached from the statue, so a mechanical cleaning process (blasting) can be used. Neither polymeric nor other organic substances were found which makes necessary a special chemical treating during the cleaning. Chlorine or other substances also did not find which could cause problem during the patinating process.

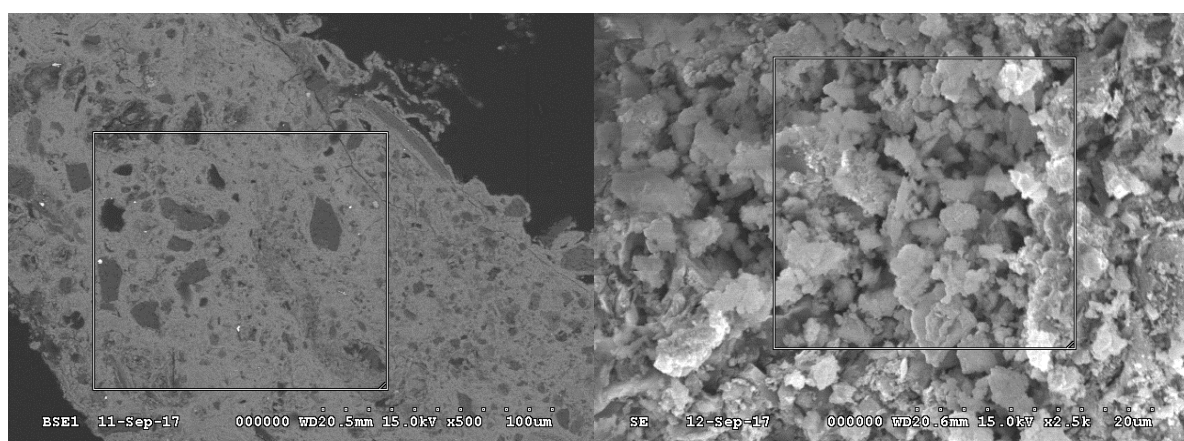
Just small amount of powder, and small parts were possible to collect from the different layers. So, a detailed SEM-EDS study was made to see the microstructure of the layer, and the local chemical compositions. SEM-EDS analysis shows the structure of the different layers. The black and yellow-brown layer built-up from particle agglomerates, where different particles, dust stuck together (Figure 3. right) The green layer is really a continuous one, where particles are integrated to a matrix. It was observed during the sampling, the black and yellow-brown layers are brittle, and these are easily detached from the surface. It was suggested to remove it during the conservation process due to this property. Additionally, in the case of yellow-brown layer EDS analysis showed high iron content, the colour of thin layer originates to the iron-oxide content.

Figure 3. The structure of the continuous green layer (left micrograph) and the yellow-brown layer (right micrograph).

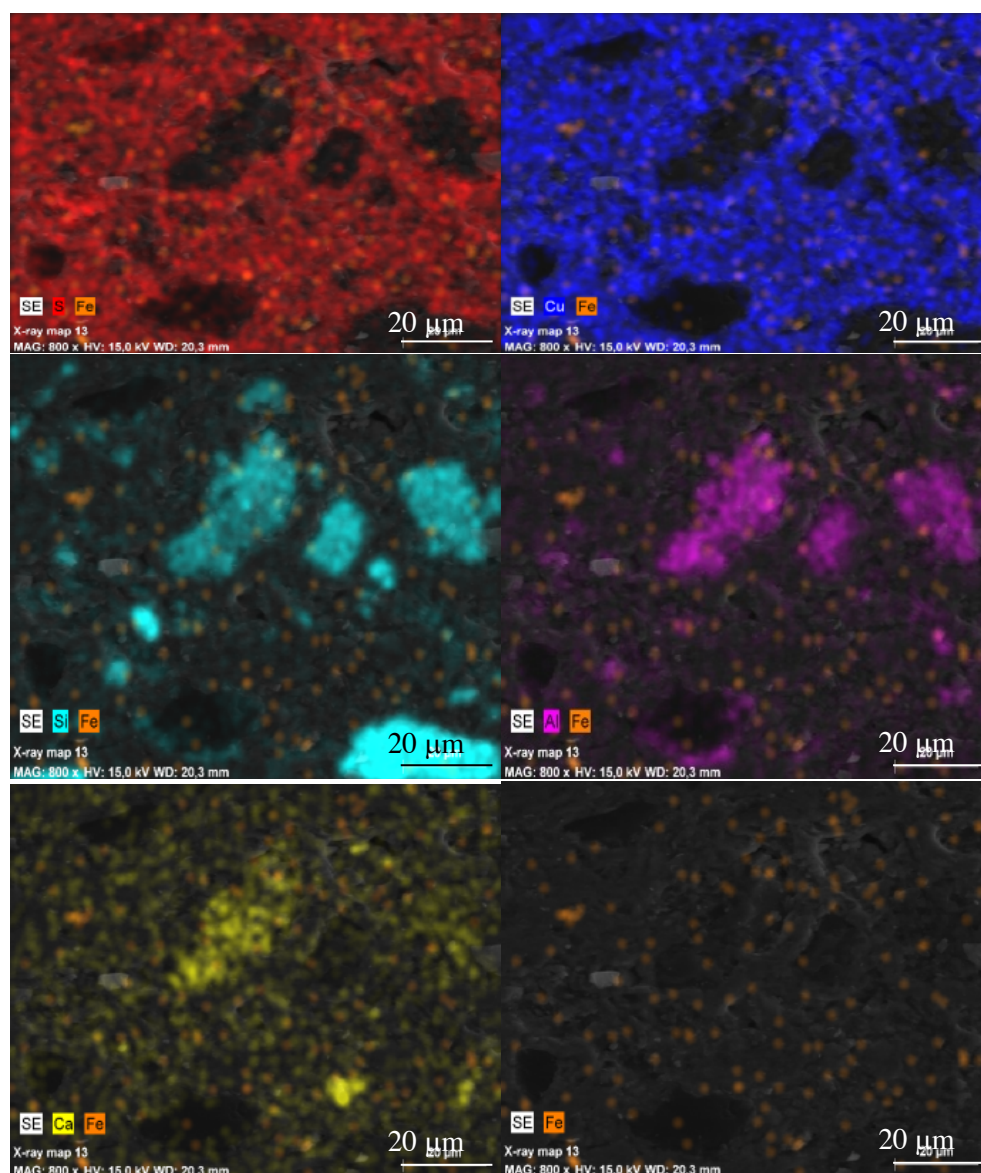
Figure 4. Element distribution map of the surface of the continuous green layer. The matrix is the patina the particles are from dust.

The green layer seems compact and it was hard to remove from the surface during the sampling. It was also analyzed, and high copper and sulfur content were measured, so this assumed as the patina layer. Figure 4 shows the distribution of different elements in a typical cross section of this layer. It reveals that the particles have a high aluminum and silicon content. These elements clearly distinguish the particles and the matrix. Calcium content detected in the particles only, which did not contain sulfur. This shows that the layer either contains calcium, but not in gypsum form, it come from the dust. An interesting observation is that the iron distribution is nearly uniform, and small particles can be seen mainly in the matrix material. Chlorine did not detect, so chlorides or other substances which contains chlorine did not exists on the surface of the statues.

These results show that the particles are also from dust, which deposited to the surface. The matrix is the real corrosion product, the patina which growth continuously during the corrosion process. The patina layer involved the dust particles with its growth process. The results of the EDS analysis and the suggestions will compare to an XRD phase analysis later.

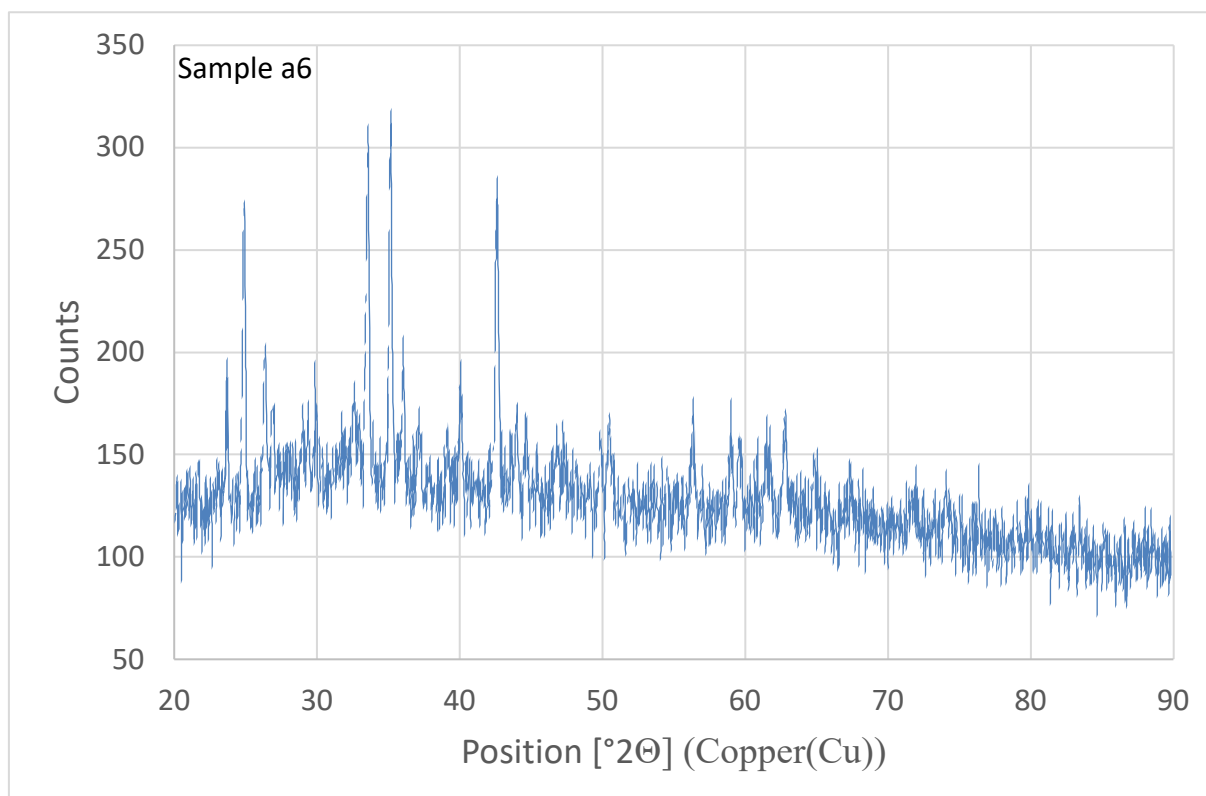
Figure 5. The XRD spectrum of the green layer.

The XRD analysis of the green layers were performed (Figure 5. sample a3). The intensity in the XRD spectra was low due to the small amount of samples but $\text{CuSO}_4 \cdot 2\text{Cu}(\text{OH})_2$ and $\text{CuSO}_4 \cdot \text{Cu}(\text{OH})_2$ were clearly identified as the components of the patina layer. The SEM-EDS observations helped to identify the different compounds. $\text{Al}_3\text{Fe}_5\text{O}_{12} + \text{SiO}_2$ identified as dust particles. Next to these SnO , CuO_2 and Fe_2O_3 oxides were found in the sample. Tin and copper oxides are also a corrosion product of the raw material. The SEM micrograph revealed the distribution of the iron-oxide particles. The XRD analysis told nothing about the status of calcium due it's small concentration.

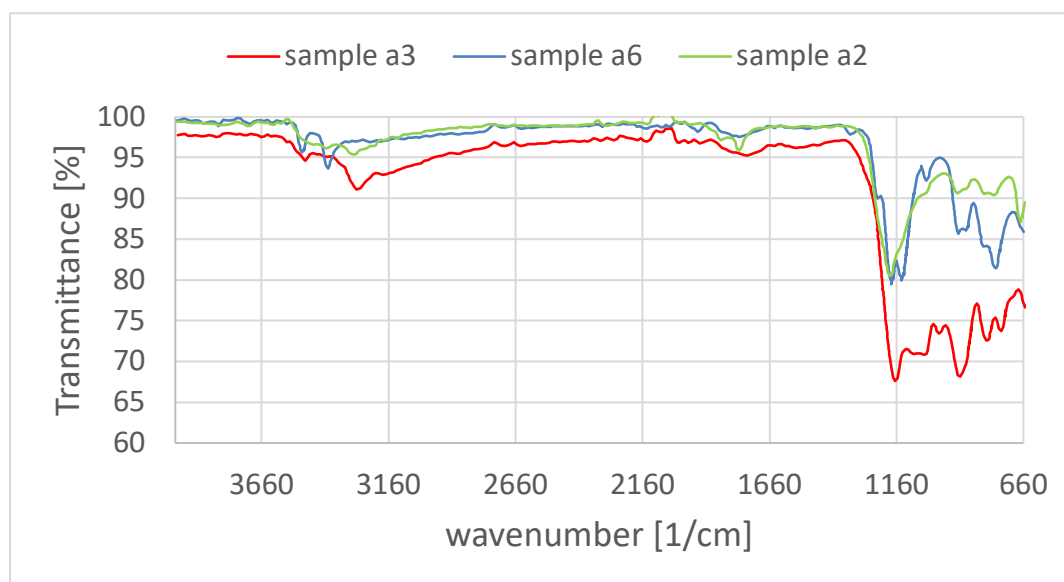
FTIR analysis of the samples performed to look for organic material or polymers from a possible previous treatment. Without any treatment the samples examined and neither organic nor polymeric materials were found (Figure 6.). The curves on Figure 6 cannot show any radicals or organic substances. Three samples were tested: a2, a3 and a6. Samples a2 and a3 are taken from green layer. Sample a2 was taken from Toldi's sword, sample a3 take from Toldi's helmet. sample a6 is a sample from the black layer and it was taken from Toldi's helmet. There is no significant difference in the FTIR spectra. Just a small amount of carbonates could be identify.

Figure 6. The FTIR spectra of three different samples of green layer.

The FTIR spectra identified only carbonates which either could be a copper compound in the patina layer or calcium-carbonate content of the dust particles. These results show another evidence the absence of gypsum in the layer.

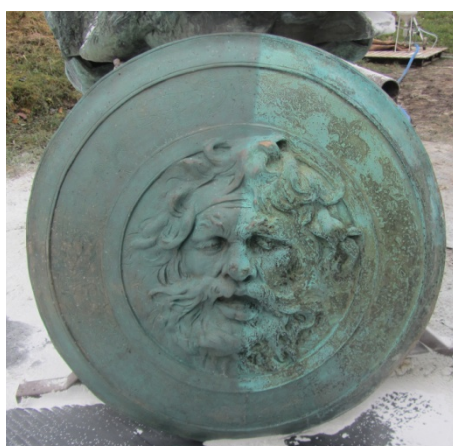
Figure 7. The Toldi's shield after the cleaning experiment.

Based on this information cleaning probes were made to choose the best cleaning, blasting agent. The results of a NaHCO_3 particles blasting is showed by figure 7.

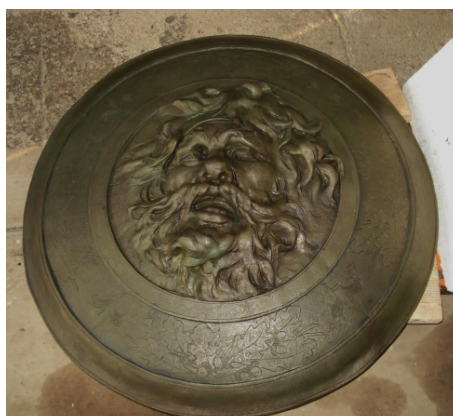
Figure 8. The cleaned and patinated shield.

The chosen cleaning process removes all undesired material from the surface, therefore other chemical treatment was not necessary just the patinating process (Figure 8.). After the patinating process a protective thin resin layer also applied which did not change the outlook of the statues just gives an additional protection.
