**UNIVERSITY OF DEBRECEN
FACULTY OF ENGINEERING
DEPARTMENT OF
MECHANICAL ENGINEERING**

**Geometric Analysis and Maintenance of a
Sprocket**

T H E S I S

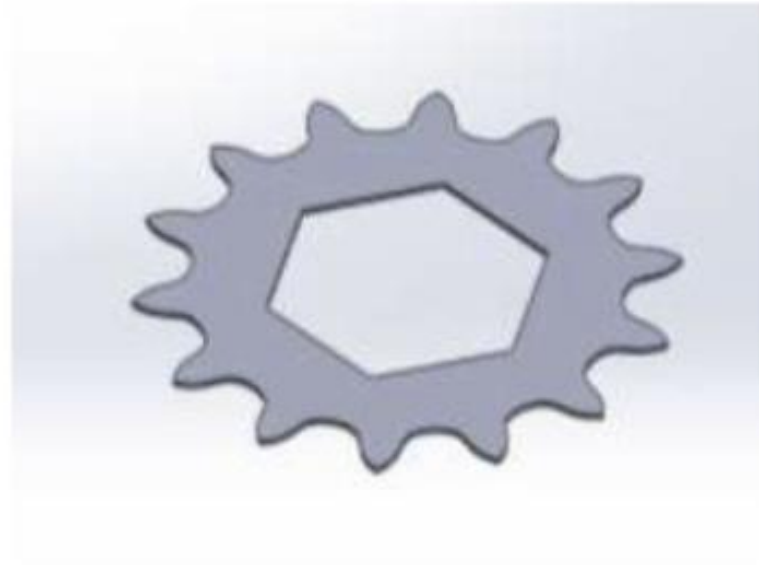
Figure 2: CAD Model of the Sprocket [3]

finish. The sprocket created showed excellent accuracy in dimensioning, which is confirming that CNC milling can be used to produce precise and accurate results that are repeatable for modern bicycle drivetrain systems [3].

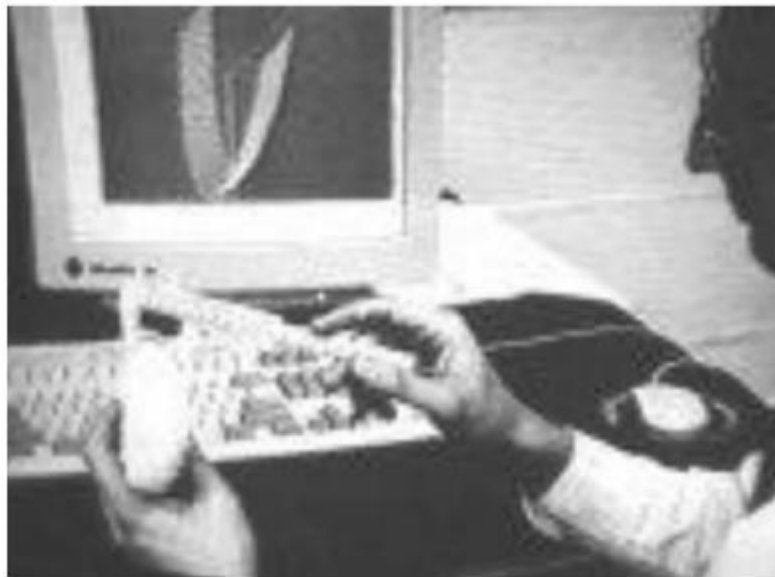
Figure 5: Object Tape Measuring [4]

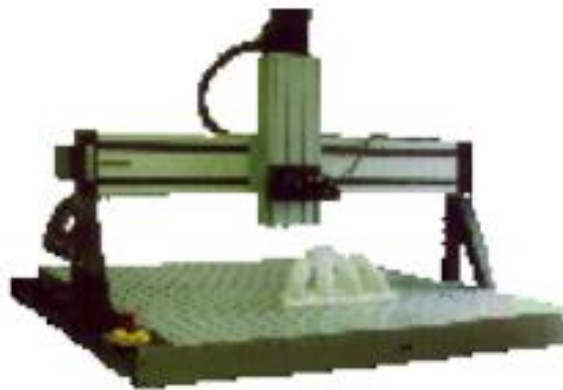
Figure 6: Replica 3D Scanner [5]

After 1985, these projection-based systems began to be replaced by laser and white-light scanner systems, which had a positive effect in speed of the scanning process and the precision of measurements. In 1994, a 3D scanner called **REPLICA** was produced which had the ability to produce very accurate scanning of very detailed objects and geometries, this specific 3D scanner used the method of laser stripe scanning [4]. Other companies were also creating their own 3D scanning products, **Cyberware** for instance, had their own high detail scanners, some of them were able to capture colour as well, although a significant

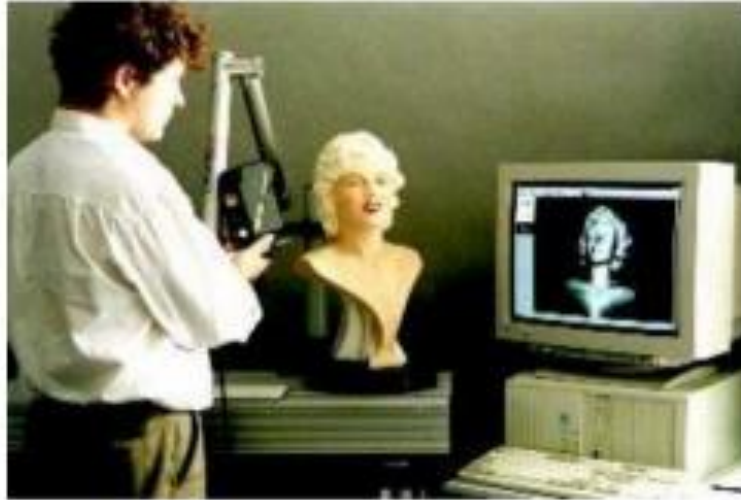
Figure 7: Manually Operated and Strip 3D Scanner [4]

In the year of 1996, a significant progression was achieved with the introduction of a 3D scanner model called the **ModelMaker**, a 3D scanner that was operated manually by hand and was installed with a stripe 3D scanner [4]. This form or hybrid setup was advantageous in the form of being fast and flexible, it was also able to capture colour as well, the **ModelMaker** was marked as one of the earliest example of integrated laser scanning for practical engineering and design tasks, the help of being manually controlled and its ability to digitize scanned data automatically was very beneficial in the area of time-saving and accurate generation of 3D models [4].

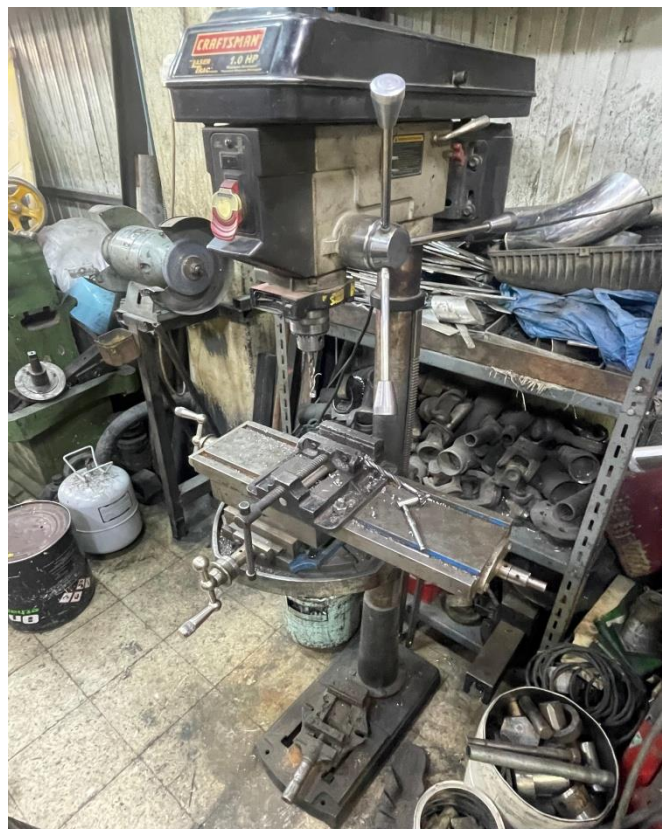
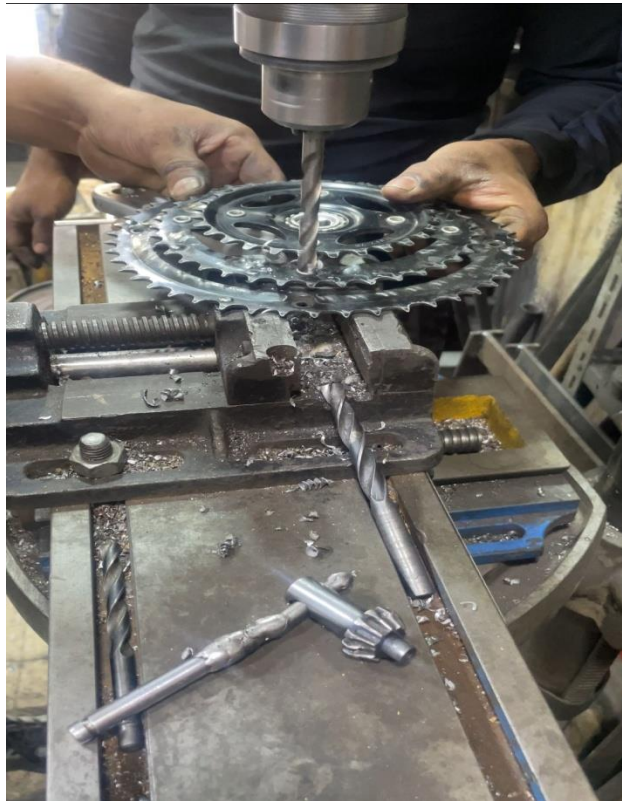
Disassembly of the sprocket system was the first step, the sprocket system was made up of 3 sprockets assembled together with rivets. These rivets held the small, medium and large sprockets as one unit. The first step was separating the assembly to allow separate access to each sprocket and therefore be scanned as an individual component. A drill press was used to remove the rivets, specifically, a Floor-standing Craftsman Drill Press, the drilling process was done vertically to remove the rivets, the usage of the vertical drilling of the drilling machine allowed for a controlled material removal and ensured that the sprockets were not damaged during disassembly.

Figure 17: Rivet Removal Process Using Drill Press

The rivet removal process needed to be carried out carefully because the purpose of this study is to analyze the real worn geometry of the sprockets, therefore any improperly controlled force, slipping of the drill or unnecessary contact with the sprocket body had to be avoided so that no additional wear or damage happens.

The removal of the rivets in a controlled way, the original condition of the sprocket surface and also the tooth regions were preserved for the following scanning and also modelling stages.

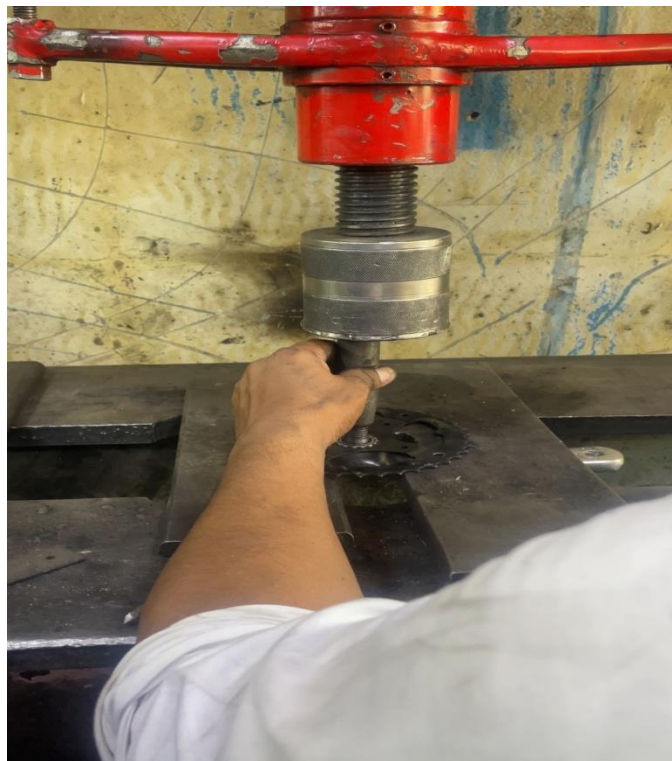
Once the fasteners have been removed the sprockets separated cleanly into three individual parts, the small, medium and large sprockets, the medium sprocket had the crank arm still attached to it, therefore it has to be removed with a hydraulic press machine, the sprocket was laid flat on its surface and the hydraulic press was aligned to remove the crank arm without damaging the teeth of the sprocket or causing any major bending to the structure.

Figure 19: Crank-arm Removal Using Hydraulic Press Machine

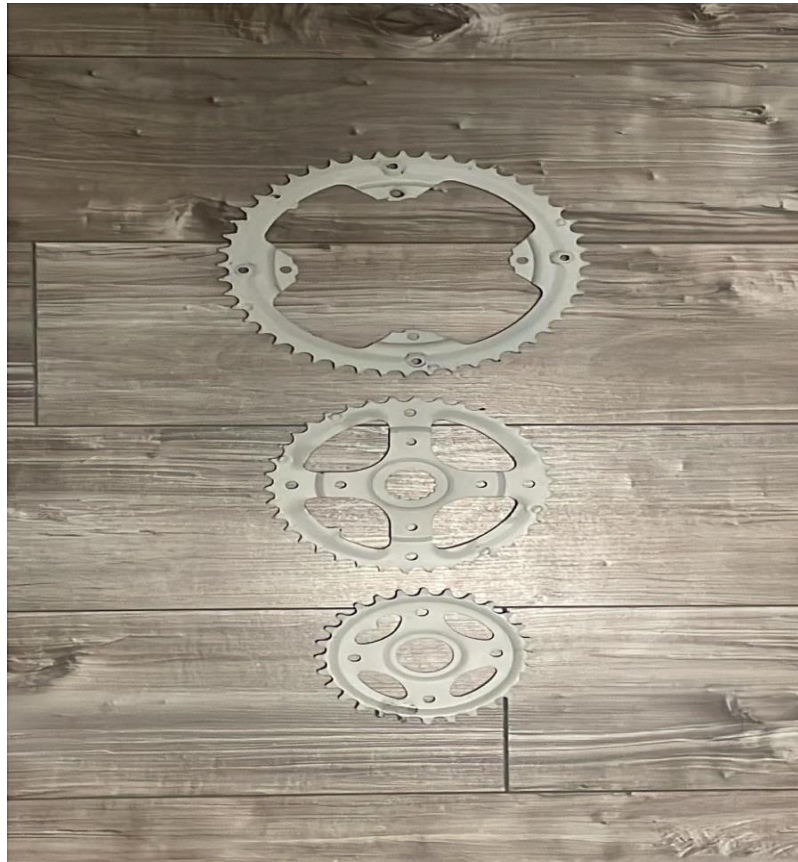
Figure 21: Sprocket System After Disassembly

The laser scanning process requires consistent surface conditions to make sure that an accurate capture of the geometry is possible. The surface of the sprocket was dark, oily and worn out, which would interfere with the laser sensor and would have reduced scanning accuracy. For that reason each sprocket was coated with a single layer of white automotive spray paint, and the reason for only a single layer is for the purpose of not creating additional surface thickness on top of the sprocket surface. The white coating improved the light diffusion, reduced the glare and enabled the scanner to detect edges and tooth surface more reliably and accurately. The coating thickness was negligible relative to the dimensions of the sprocket teeth and did not effect the scanning results.

It is important to minimize the coating thickness as much as possible as to make sure that even the smaller difference caused by the wear are not hidden or undetected by the 3D laser scanning process, therefore providing as accurate result as possible.

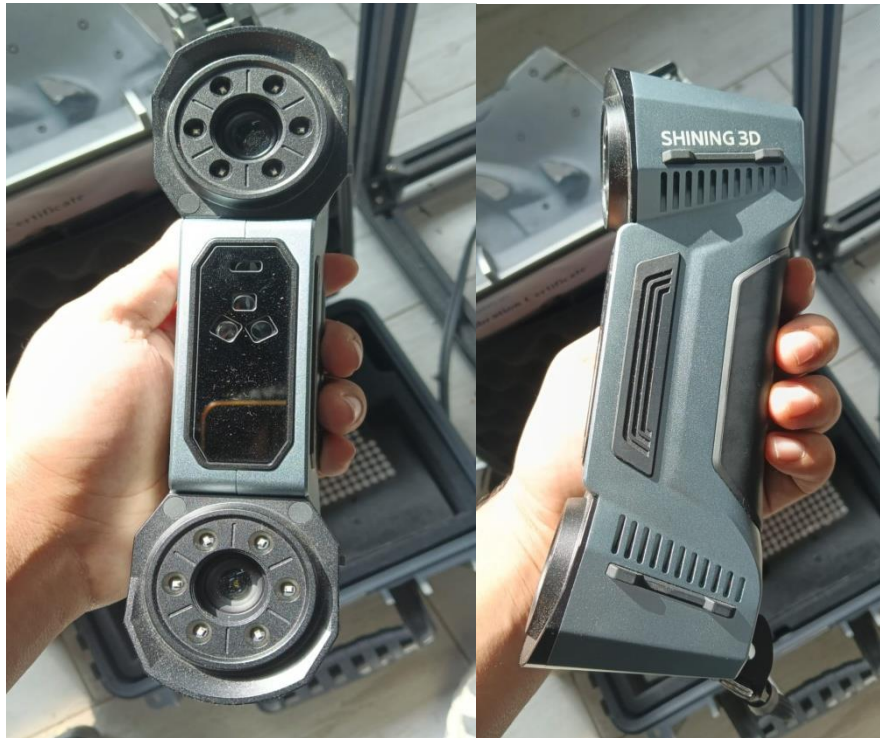
Figure 22: Shining 3D FreeScan Combo

After the disassembling and coating the sprockets, the scanning process was performed using the **Shining 3D FreeScan Combo**, a portable high accuracy laser line scanner that was suitable for scanning mechanical parts. The laser line mode was selected because it provides precise results for metallic components with complex edges such as sprocket teeth. The **Shining 3D FreeScan Combo** is specifically good for this study due to the following reasons, in the laser scanning mode which was used, it has a very high scanning accuracy, which was sufficient for the purpose of this study. Each sprocket was placed individually on a turntable. The turntable allowed smooth rotation of the sprocket during scanning, which helped make sure the scanner captured all surfaces, including tooth flanks, inner edges and the hub region.

Also, the selection of the scanner is important because the sprockets contain some relatively small geometric features, for example, the tooth flanks and tips, where the wear is expected to be more concentrated there.

A scanner with insufficient accuracy, could have reduced the reliability of the comparison between the worn and the restored models that would be generated from these scans, for this reason, a high accuracy scanner was needed to make sure that the comparison would be as reliable and accurate as possible.

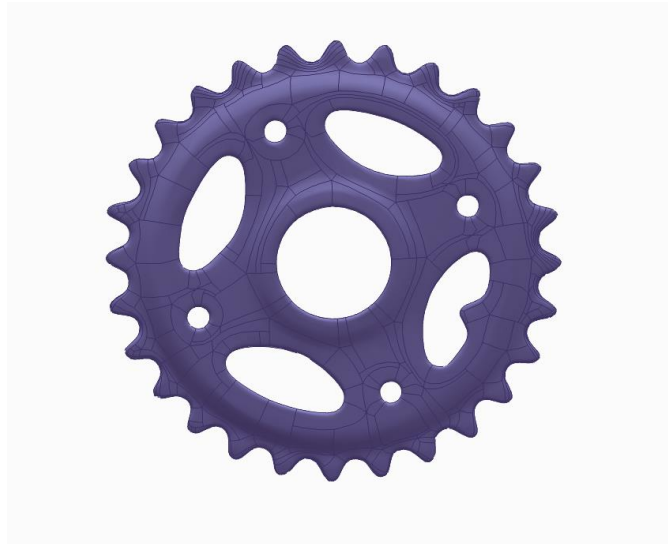
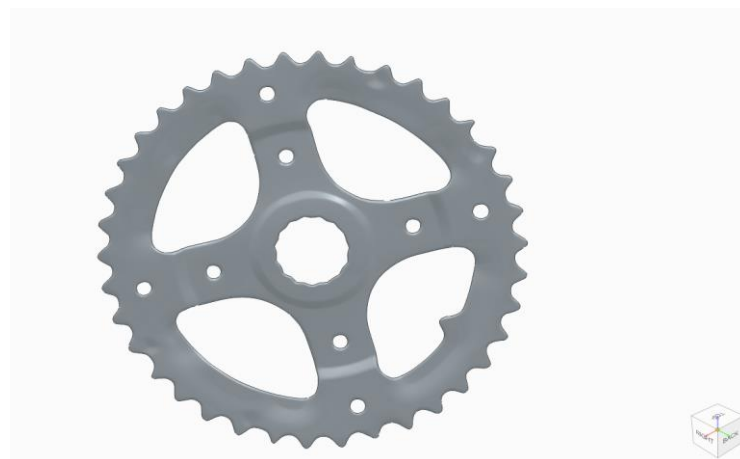
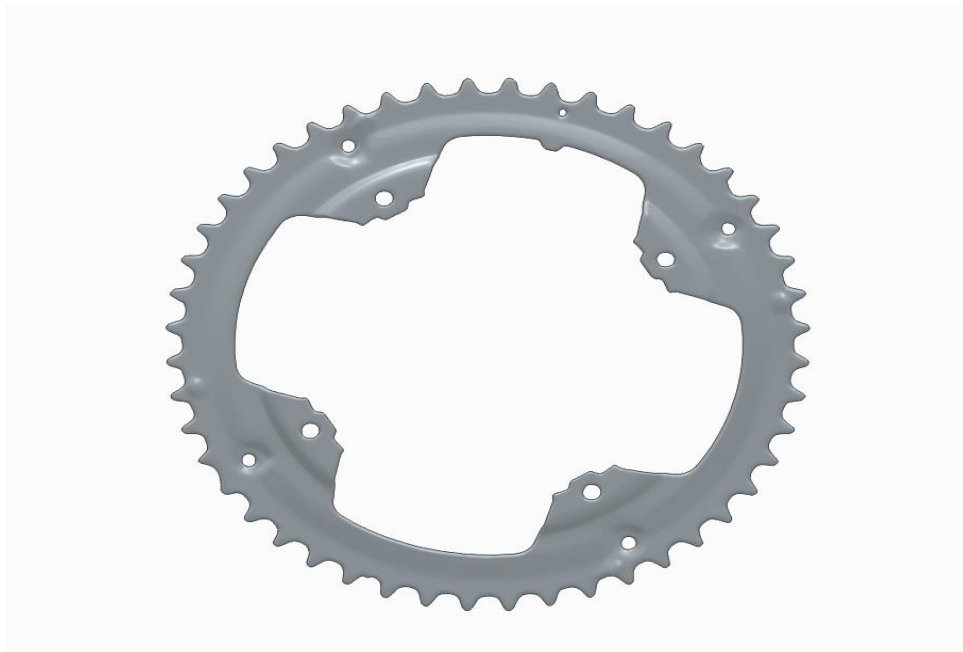
After the scanning of each sprocket, this allowed the progression into the next step which was to generate a solid CAD model for each sprocket using the help of the reverse engineering features of the software. In this process the mesh geometry of the worn sprocket was the one used directly to generate these models, which basically means that the models were created and derived from the mesh itself, rather than creating them independently. The reverse engineering tools in the software interpreted the mesh and generated the solid geometry while at the same

time they preserved the main dimensions and shape of the scanned part. There are now 3 separate solid models for each sprocket which was necessary for the next step, which required the controlled and manual editing of the tooth geometry, without the conversion into a solid CAD model, this modification would have been practical.

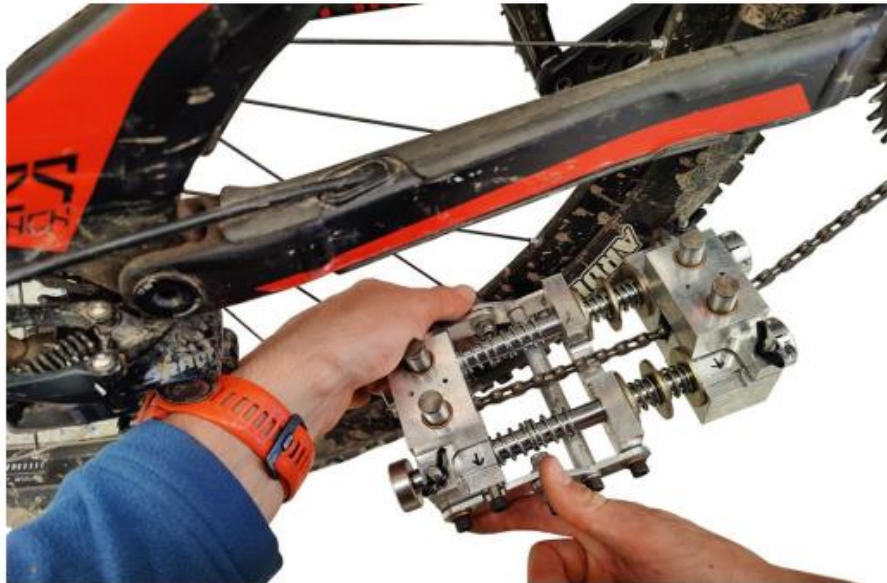
Figure 38: Chain wear checker in-situ operation [15]

Since this study showed that the tooth region of the sprocket is the main area of deterioration, measuring chain wear regularly would help reduce tooth damage caused by a worn chain that is continuing to engage with the sprocket.

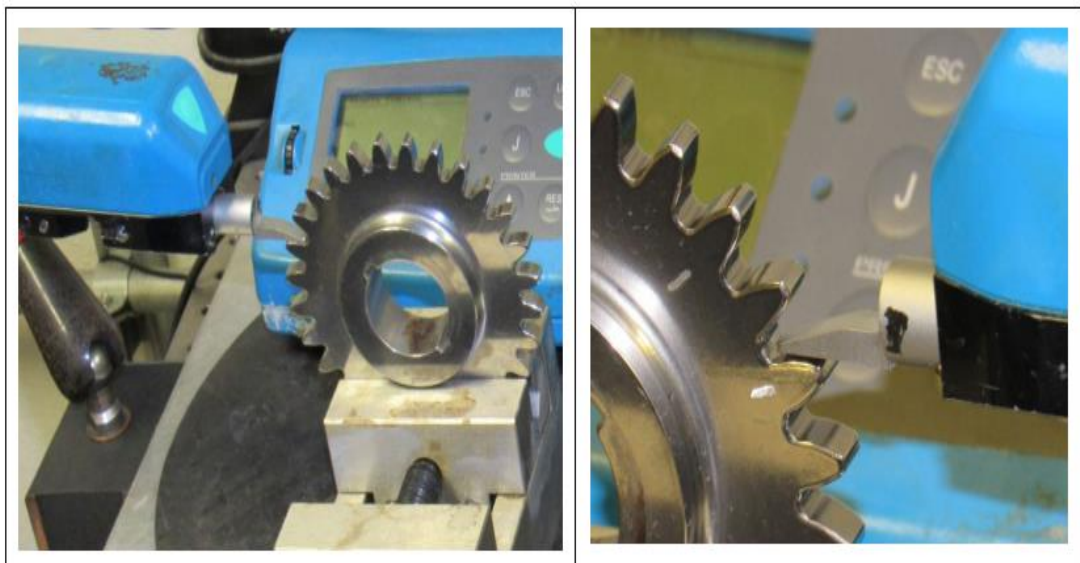
Surface roughness measurement also helps with predictive maintenance, if the surface condition of the tooth of the sprocket is measure at repeated intervals, the maintenance planner can observe whether the roughness is still at a stable or acceptable condition, or if it is increasing rapidly, stable surface condition suggests that the lubrication and operating condition are good, on the other hand a rapid increase in the roughness of the tooth profile suggests that the system is moving towards a more severe state in the wear, such information can help in estimating the future maintenance needed [16].

Figure 39: Profilometer (“Shop Floor” Model) [16]

Figure 40: Profilometer (“Metrology Lab” Model) [16]
