**UNIVERSITY OF DEBRECEN  
FACULTY OF ENGINEERING  
DEPARTMENT OF  
MECHANICAL ENGINEERING**

# **Failure Map generation by NDT on Metal Sprayed Multi-surfaces**

**T H E S I S**

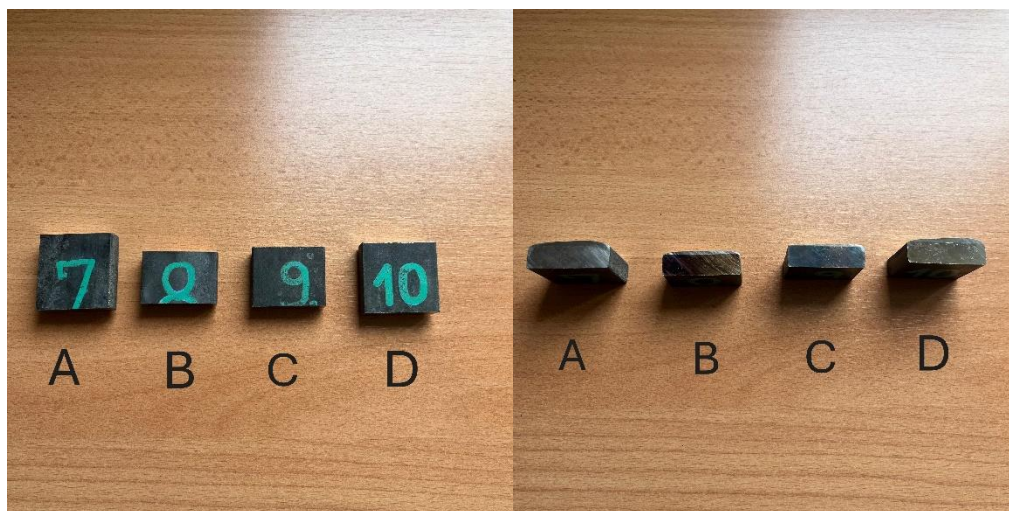
Figure 3.1 – General view on the specimens

General view on the examined samples is presented on the Figure 3.1.

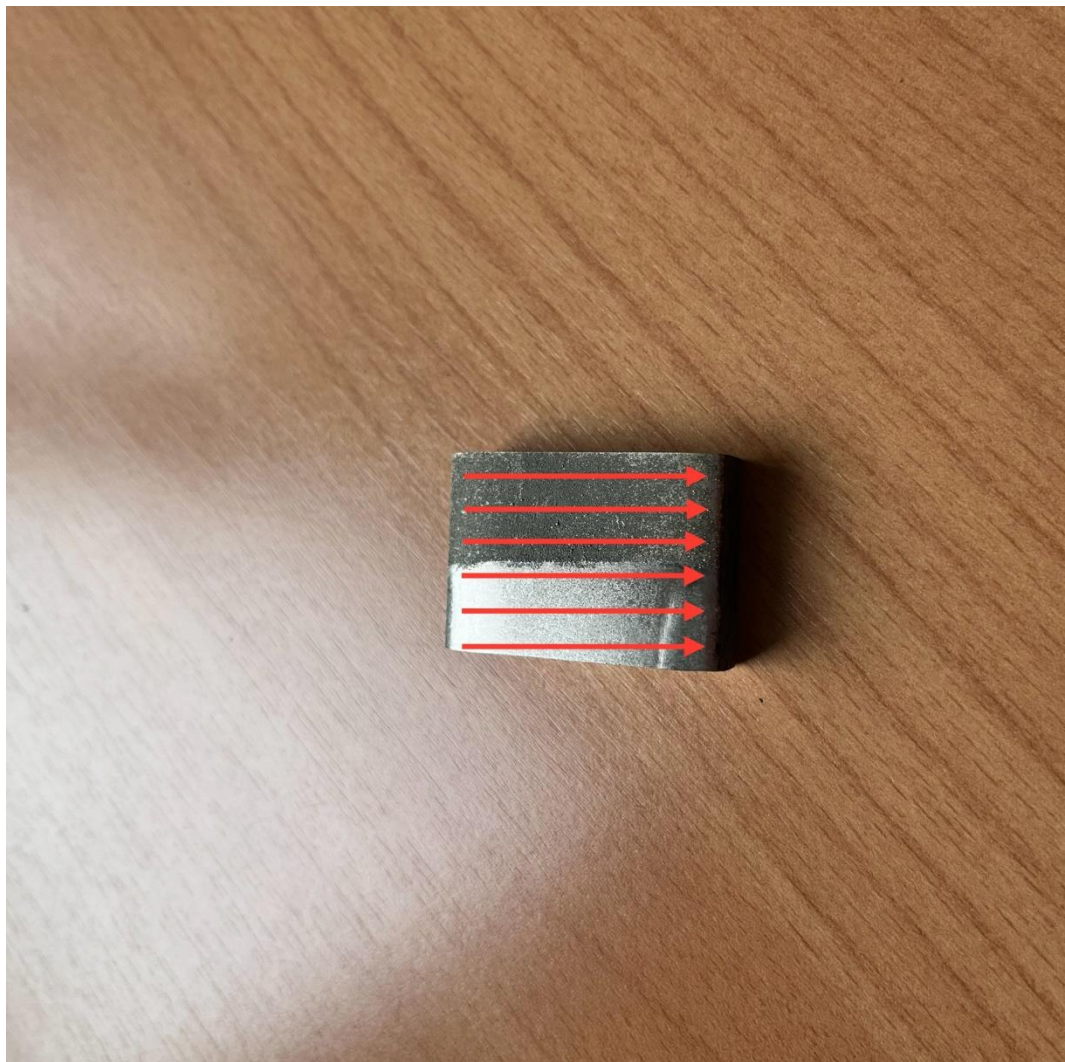
Figure 4.4 – Linear parallel movement pattern

Due to these limitations, the serpentine pattern was replaced by a **linear parallel scanning strategy**, where the probe was moved consistently in one direction along parallel lines. This approach provided:

Each specimen was scanned in six to nine parallel lines, ensuring sufficient spatial resolution.

That is precisely why it was decided to change the position of the component during the inspection and to choose a different pattern that would simplify our tasks. It was decided to inspect the parts from a different angle, positioning them horizontally so that, during inspections, the measuring probe would always be in contact only with the surface for which it had originally been calibrated. That final specimen position and final movement pattern can be seen on Figure 4.4

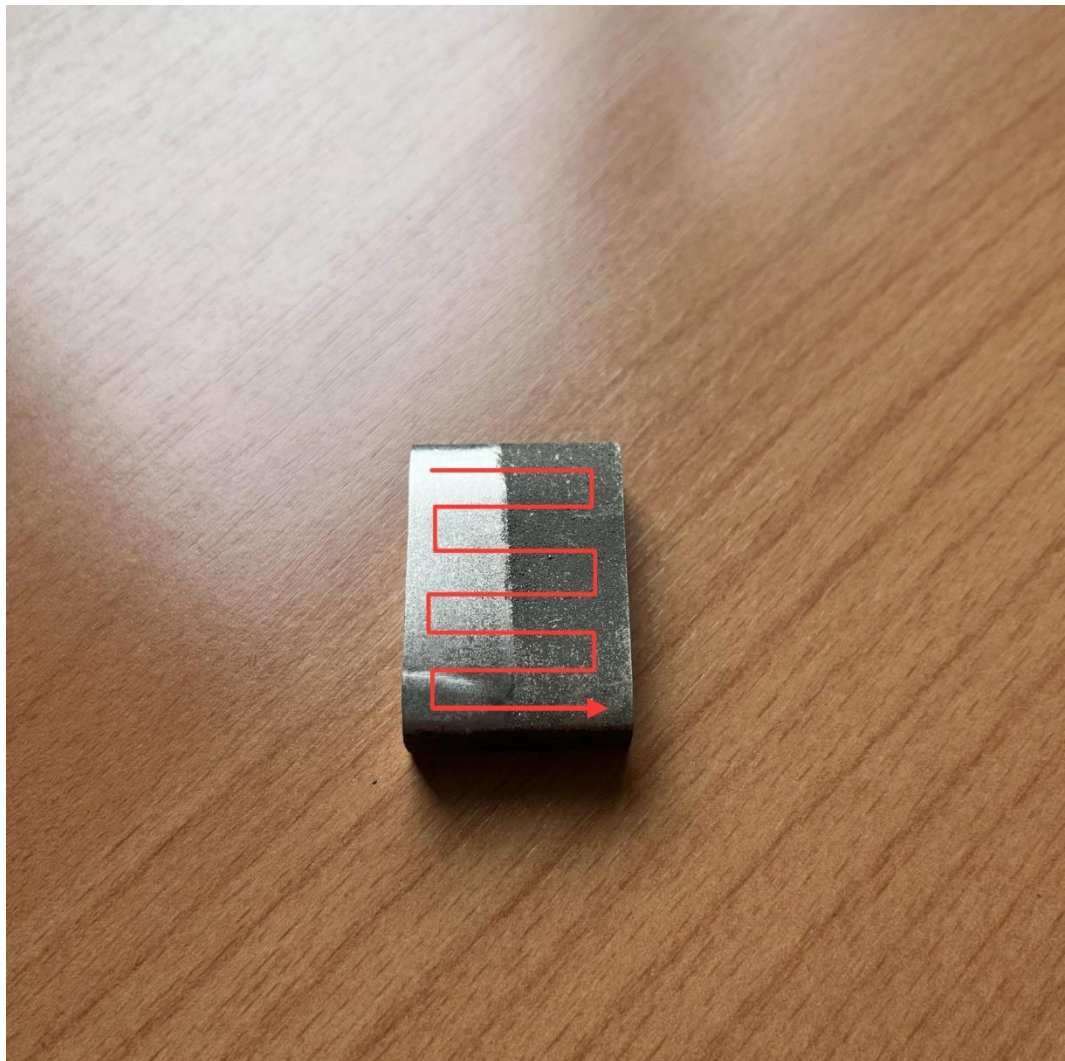
Figure 4.5 – Serpentine movement pattern

The first mistake made was choosing an unsuitable method for inspecting our metal-coated parts for defects. Instead of using the linear pattern mentioned above, we used a serpentine (zig-zag) pattern. (See Figure 4.5)

During the inspection of parts, this type of pattern, due to the tool head moving alternately in one direction and then in the other, results not in a linear function, but

- A large volume of data that is difficult to work with and makes it hard to trace errors. In other words, if a mistake is made during the inspection of a part, the entire procedure must be started from the beginning
- Increased sensitivity to inconsistencies because of the operator
- Due to the non-linear nature of the function, data recording also takes place in a non-linear manner, which significantly complicates the process of creating 3D defect maps
- Difficulty in correlating spatial coordinates with measured data
