Operational experience with the CMS pixel detector

PIXEL 2014 INTERNATIONAL WORKSHOP
SEPTEMBER 1–5, 2014
NIAGARA FALLS, CANADA

J. Karacsi on behalf of the CMS collaboration

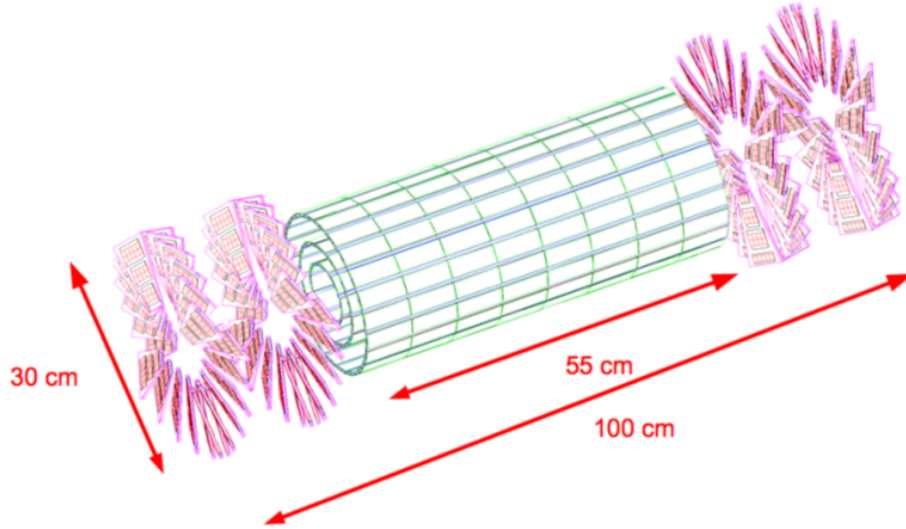
Figure 1. Schematic view of the CMS Silicon Pixel detector. The interaction point is surrounded by three cylindrical barrel layers at radii of 4.4, 7.3 and 10.2 cm and two endcap disks on each side with modules between 6 and 15 cm from the beam axis.

The sensors consist of high dose n-implants inserted into a high resistance n-substrate with rectifying pn-junctions on their backside, and are connected with readout chips (ROCs) by indium bump-bonds. The total number of pixels is approximately 66 million, each with a cell size of $100 \times 150 \mu\text{m}^2$. There are all together 15840 ROCs located on three barrel layers and two endcap disks (figure 1).

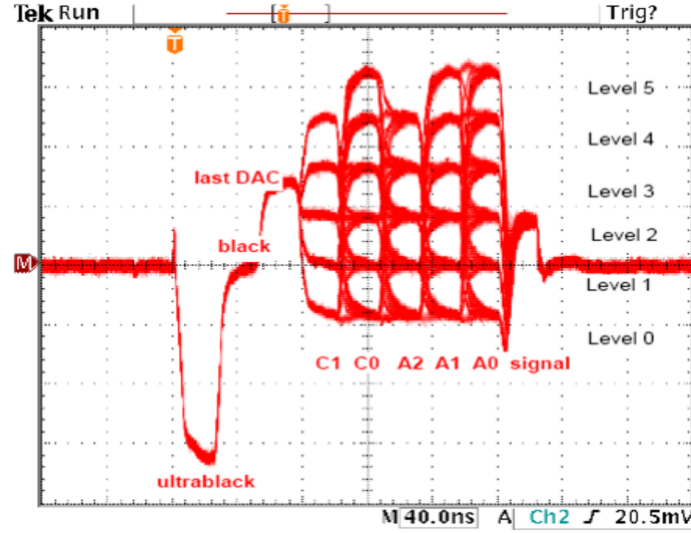
Figure 2. Oscilloscope view of the analogue signal for a pixel hit.

In the commissioning period and throughout running the different components of the detector need to be calibrated in order to ensure fully efficient and reliable data collection. The analogue signal (figure 2) consists of data packets that contain the information about each pixel hit. The pixel coordinates are encoded by using a six-level address scheme, while the charge information is contained in the analogue pulse height of the last clock cycle [4].

The offset of the optical receiver in the Front End Driver (FED) needs to be set such that the baseline level of the converted analogue signal is at the middle of the ADC range. This calibration is sensitive to temperature changes and needs to be done frequently, but small adjustments are done automatically to correct for small fluctuations. The address level calibration, which is usually done after the baselines are set, ensures that the ADC values corresponding to each address level are well separated and pixel coordinates can be decoded correctly.

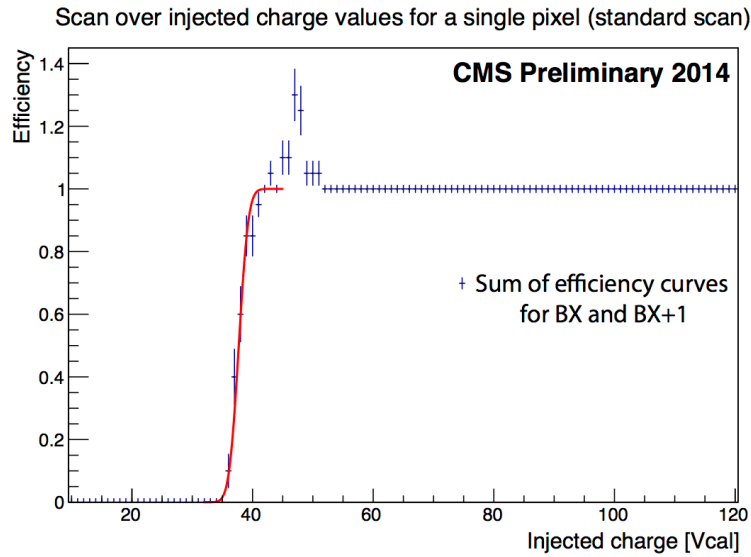
Figure 3. Sum of in- and out-of-time charge collection efficiencies as a function of injected charge.

Another set of calibrations needs to be done every few months due to the aging of the detector. One of them is the threshold calibration for which electric charges are injected through a circuit on the readout chip and the efficiency is measured. A scan is done for each pixel in units of V_{cal} which corresponds to 65.5 electrons. The efficiency is measured and the threshold is derived from a fitted turn-on curve (figure 3). The measurement [5] is then repeated in an iterative way for various ROC threshold settings in order to minimise the thresholds.

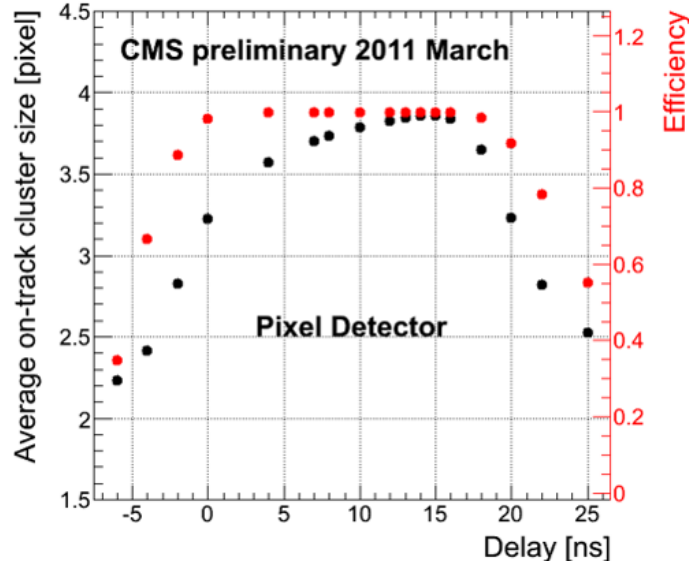
Figure 4. Average cluster size and hit efficiency vs. time delay with respect to the LHC clock.

Usually once per year, at the beginning of data taking the timing calibration of the detector is done in which the pixel detector clock is synchronized with the LHC collisions. A scan is done for various settings of the relative phase delay with respect to the LHC clock. A delay is chosen that ensures the collection of the high pixel charges and also gives enough time for most of the smaller charge pulses to cross the readout threshold in the same 25 ns readout window. The goal is

to maximise both the hit- and the charge collection efficiency (figure 4) and to allow the usage of smaller thresholds which then improves the hit resolution. Therefore a point is chosen near the end of the efficiency plateau.

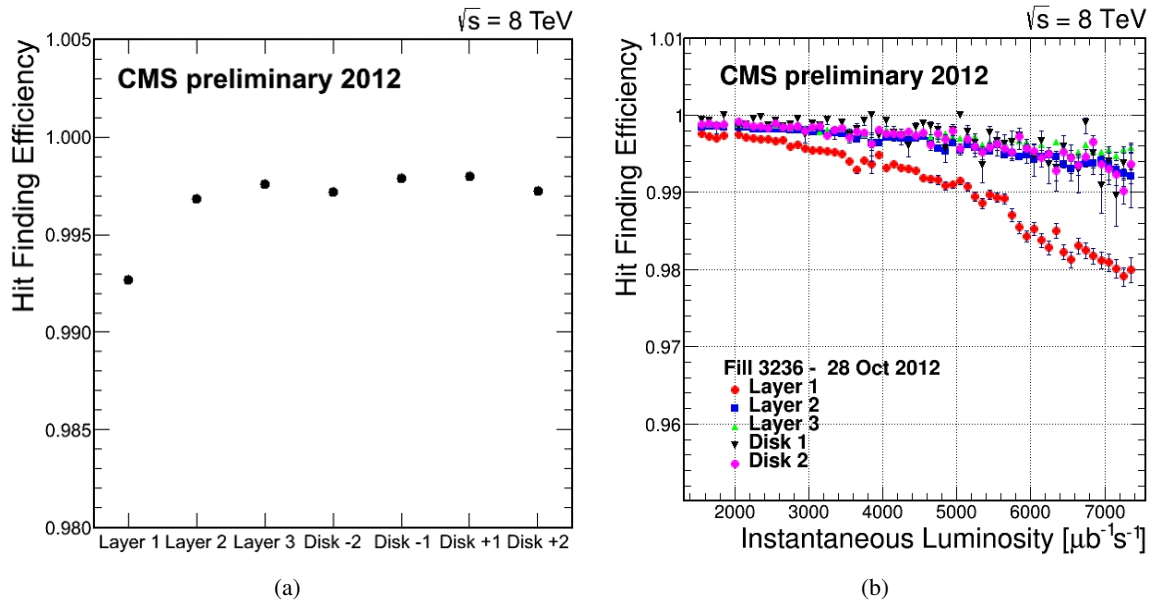
Figure 5. The hit finding efficiency for all barrel layers and endcap disks (a) on average in 2012 and (b) as a function of instantaneous luminosity in a longer LHC fill.

The hit efficiency is an important parameter to monitor throughout data taking. It is defined as the probability to find a cluster along a charged particle trajectory. Nonfunctioning modules or those that were affected by a single event upset are excluded from the measurement. The method is explained in more detail in [6]. In 2012 the average efficiency of the detector was above 99% for all layers and disks (figure 5). Compared to the outer part of the detector, the innermost layer experienced a lower efficiency, on average 99.27%, due to the higher particle flux. This is an expected behavior, due to the limited buffer size in the current readout chip [7]. The inefficiency depends on the instantaneous luminosity as shown in figure 5(b).
