Conservation purpose material testing of corrosion products on outdoor bronze statues

Abstract. A detailed material testing was carried out before the conservation project of the János Arany statues of Garden of Hungarian National Museum. The scope of the testing to analyse the corrosion products on the surface and help to develop the best cleaning and protection practice. Samples were taken from more areas and the samples were analysed by SEM-EDS, XRD, FT-IR methods. This article introduces the results of the testing and the relevant effect to the conservation process.

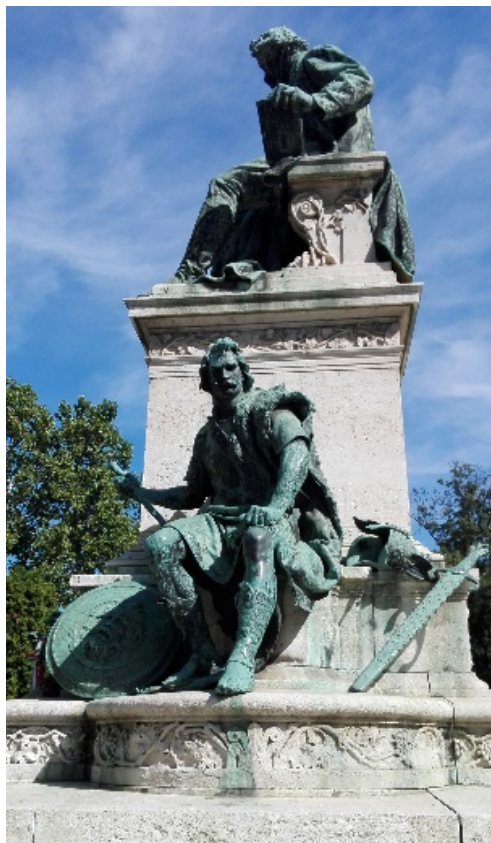
Figure 1. The statue of János Arany and Toldi at the front of the Hungarian National Museum.

The results suggest that it was necessary to remove the black and the yellow-brown layer from the surface of the statue. The green layers could be left over the surface and could be used a patinating process to equalize the outlook of the surface. The black and yellow-brown layers are brittle layers and easily detached from the statue, so a mechanical cleaning process (blasting) can be used. Neither polymeric nor other organic substances were found which makes necessary a special chemical treating during the cleaning. Chlorine or other substances also did not find which could cause problem during the patinating process.
