# Experimental Biomechanical study on the consequences of dashboard injury of the pelvis after total hip replacement

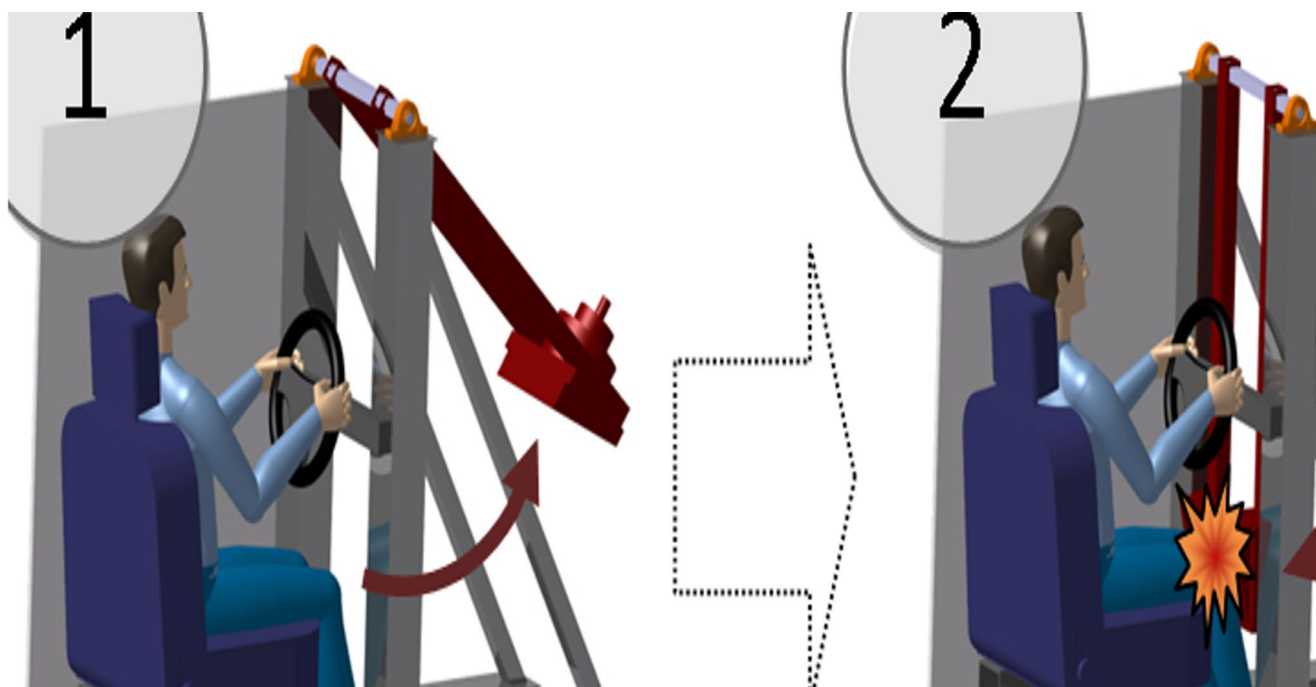
Fig. 1 Schematics of the hitting frame simulating dashboard

A hitting frame simulating dashboard injury was developed (Fig. 1). The eleven hemipelvis were fixed with epoxy resin (KEMAPOX Grund 2000, Murexin) to the hitting frame. The femur was simulated with a metal rod that had the proximal part of a femoral component of the prosthesis fixed to it to articulate with the cemented acetabular cup (Fig. 2). To the vertical part of the frame, a pendulum-like structure was fixed that was released from different heights to impact the distal end of the metal rod simulating the femur. The impact occurred in the neutral position of the hip without ab- or adduction. The force of impact could be changed by increasing the angle and weight. The distal end was

fitted with a 2.5 kN load cell (Dynacell, Instron Ltd, High Wycombe, UK) which recorded the force of impact through Instron Max software (Instron Ltd, High Wycombe, UK).
