Title: A randomised controlled study on the effects of different surface treatments and adhesive self-etch functional monomers on the immediate repair bond strength and integrity of the repaired resin composite interface using 3D surface profilometry and scanning electron microscopy

To appear in: *Journal of Dentistry*

Short title: Repair bond strength and integrity of repaired resin composite

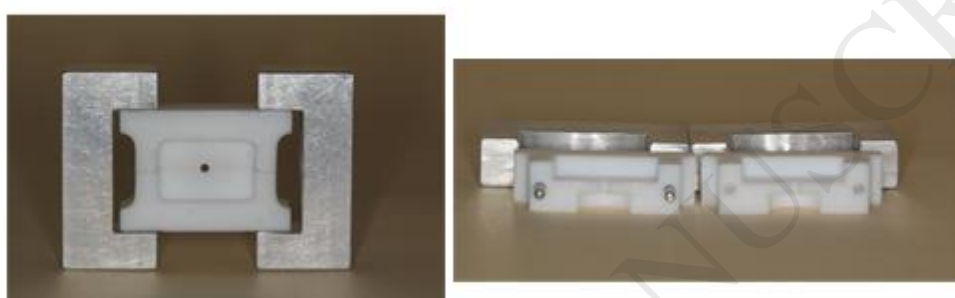
Fig.1 Custom design Teflon mold

The repair resin composite was identical in type and brand to the substrate resin composite material. The base of the Teflon molds had a prepared cylindrical recess of 2mm diameter and 2mm depth which was used for the resin composite application procedure. In the six test groups and the positive control group, the universal nanohybrid resin composite material was packed using a flat plastic instrument into the cylindrical recess and light cured (Bluephase 20i, Ivoclar Vivadent, Lichtenstein) for 20s. In the positive control group, the repair resin composite was immediately applied on the prepared fresh resin composite substrate. All surface treatment and resin composite application procedures were performed by a single experienced operator in accordance with the manufacturers' instructions.

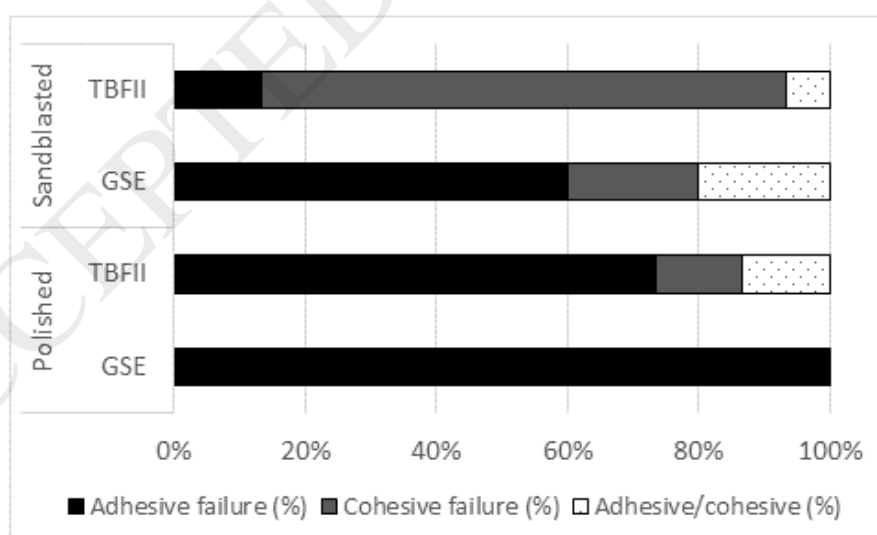
Fig. 2. Failure mode (%) of the investigated composite samples.

Optical microscopy examination showed that polished specimens had significantly more adhesive failures than sandblasted surfaces ($p=0.001$). Specimens treated with polishing and GSE (Group 1) showed 100% adhesive failures, whereas those treated with polishing and TBF II (Group 2) showed 73% adhesive failure. In contrast, the sandblasted surfaces conditioned with TBF II (Group 5) showed mostly cohesive failures (80%), while the sandblasted surfaces conditioned with GSE (Group 4) showed predominantly adhesive failures (60%). A summary of the findings is shown in Fig. 2.
